**Flood Control Project Maintenance  
Levee Inspections**

**Fall 2016 Levee Maintenance Deficiency Summary Report**

**Sacramento River Basin**

**City of Sacramento**

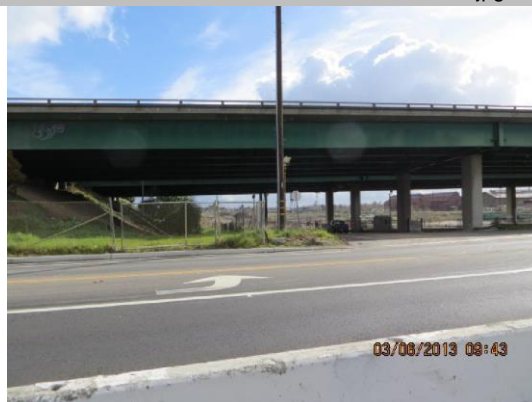
Photo 1 of 2 : UCIP\_FA\_2016\_49955\_33806.jpg

Comment Code					
Inspector Comment					
FS_ID:49955 DS_ID:21559 EP_NO: 14527 Repair Type: Non-Urgent Crossing Status: Found UCIP Comments: 7/19/2016 Paddle marker missing from WS--owner will need to work with CVFPB to determine if paddle marker on WS is necessary. (DWR UCIP - omagana)3/22/2016 Need to contact owner to determine condition of crossing and last inspection date. (DWR UCIP - omagana) FIELD_STRUCT_DESC: 12.75-inch steel gas line through levee (right bank), unable to confirm depth below the crown. Permit indicates the pipeline shall be buried with a minimum cover of 1 feet in the levee slopes and 2 feet through the levee crown. Line was directionally bored under the left bank levee and low water channel at a minimum cover of 44 feet and 21 feet, respectively. Paddle marker located approximately 150 feet from levee crown on landside (LS). (Permit No. 14527, 1987 - Southern Pacific Pipelines, Inc.) [Additional Reference(s): DWR Levee Log, 1993] FS Date: 7/19/2016

View of levee crown at crossing--sign visible on landward side near freeway underpass.

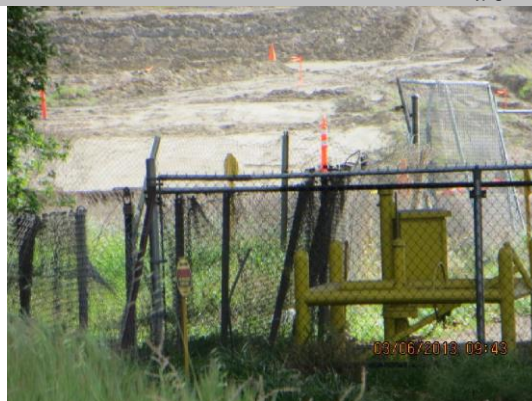
Photo 2 of 2 : UCIP\_FA\_2016\_49955\_33805.jpg

Item	DWR UCIP Field Study			38.589864 °	38.589864 °	
				-121.505128 °	-121.505128 °	
DWR ID						
Comment Code						
Inspector Comment						
FS_ID:49955 DS_ID:21559 EP_NO: 14527 Repair Type: Non-Urgent Crossing Status: Found UCIP Comments: 7/19/2016 Paddle marker missing from WS--owner will need to work with CVFPB to determine if paddle marker on WS is necessary. (DWR UCIP - omagana)3/22/2016 Need to contact owner to determine condition of crossing and last inspection date. (DWR UCIP - omagana) FIELD_STRUCT_DESC: 12.75-inch steel gas line through levee (right bank), unable to confirm depth below the crown. Permit indicates the pipeline shall be buried with a minimum cover of 1 feet in the levee slopes and 2 feet through the levee crown. Line was directionally bored under the left bank levee and low water channel at a minimum cover of 44 feet and 21 feet, respectively. Paddle marker located approximately 150 feet from levee crown on landside (LS). (Permit No. 14527, 1987 - Southern Pacific Pipelines, Inc.) [Additional Reference(s): DWR Levee Log, 1993] FS Date: 7/19/2016

View of multiple markers indicating gas alignment.

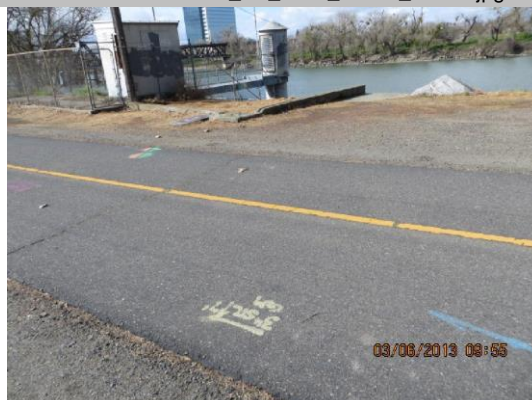
Photo 1 of 2 : UCIP\_FA\_2016\_41414\_72622.jpg

LM Start	0.14	Rating **	M	Issue No.	828
LM End	0.14	Issue Type +	En	Location *	N/A
Category	Supplemental			GPS Latitude/Longitude	
				Start	End
Item	DWR UCIP Field Study			38.588768 °	38.588768 °
				-121.504891 °	-121.504891 °
DWR ID					
Comment Code					
Inspector Comment					
FS_ID:41414 DS_ID:24882 EP_NO: N/A Repair Type: Non-Urgent Crossing Status: Indicator Found UCIP Comments: Need to contact owner to determine status of crossing. No permit found during desk study review. FIELD_STRUCT_DESC: 42 inch water transmission main through levee at unknown depth. Crossing installed in 1966. FS Date: 3/6/2013

View of levee crown and waterward side.

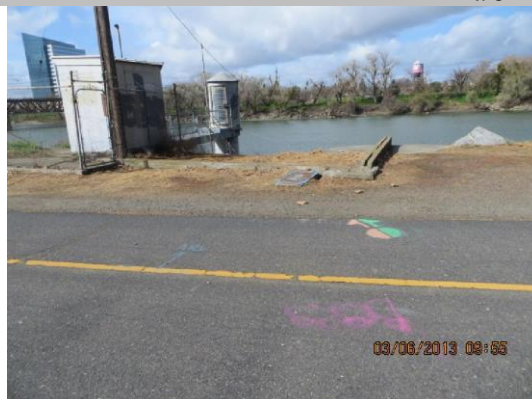
Photo 2 of 2 : UCIP\_FA\_2016\_41414\_72621.jpg

LM Start	0.14	Rating **	M	Issue No.	828 (cont)
LM End	0.14	Issue Type +	En	Location *	N/A
Category	Supplemental			GPS Latitude/Longitude	
				Start	End
Item	DWR UCIP Field Study			38.588768 °	38.588768 °
				-121.504891 °	-121.504891 °
DWR ID					
Comment Code					
Inspector Comment					
FS_ID:41414 DS_ID:24882 EP_NO: N/A Repair Type: Non-Urgent Crossing Status: Indicator Found UCIP Comments: Need to contact owner to determine status of crossing. No permit found during desk study review. FIELD_STRUCT_DESC: 42 inch water transmission main through levee at unknown depth. Crossing installed in 1966. FS Date: 3/6/2013

Underground Service Alert (USA) markings indicating 42 inch line through levee.

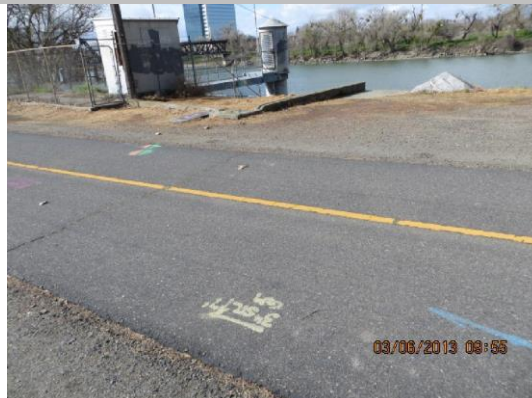
Photo 1 of 2 : UCIP\_FA\_2016\_41415\_72630.jpg

LM Start	0.14	Rating **	M	Issue No.	829
LM End	0.14	Issue Type +	En	Location *	N/A
Category	Supplemental			GPS Latitude/Longitude	
				Start	End
Item	DWR UCIP Field Study			38.588738 °	38.588738 °
				-121.504891 °	-121.504891 °
DWR ID					
Comment Code					
Inspector Comment					
FS_ID:41415 DS_ID:24883 EP_NO: N/A Repair Type: Non-Urgent Crossing Status: Indicator Found UCIP Comments: Need to contact owner to confirm alignment and status of crossings. No permit found during desk study review. FIELD_STRUCT_DESC: ARV communication line and 3-inch STL communication line on levee. FS Date: 3/6/2013

Underground Service Alert (USA) markers visible on levee crown.

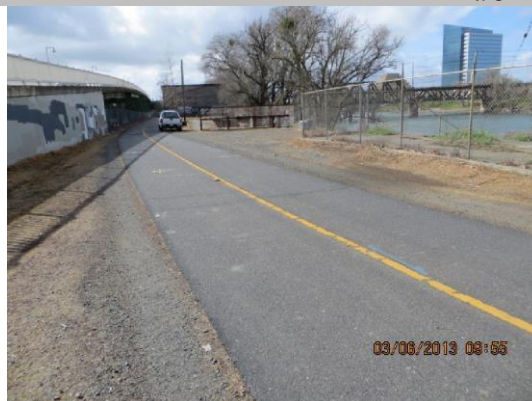
Photo 2 of 2 : UCIP\_FA\_2016\_41415\_72623.jpg

LM Start	0.14	Rating **	M	Issue No.	829 (cont)
LM End	0.14	Issue Type +	En	Location *	N/A
Category	Supplemental			GPS Latitude/Longitude	
				Start	End
Item	DWR UCIP Field Study			38.588738 °	38.588738 °
				-121.504891 °	-121.504891 °
DWR ID					
Comment Code					
Inspector Comment					
FS_ID:41415 DS_ID:24883 EP_NO: N/A Repair Type: Non-Urgent Crossing Status: Indicator Found UCIP Comments: Need to contact owner to confirm alignment and status of crossings. No permit found during desk study review. FIELD_STRUCT_DESC: ARV communication line and 3-inch STL communication line on levee. FS Date: 3/6/2013

Overview of levee crown looking downstream.

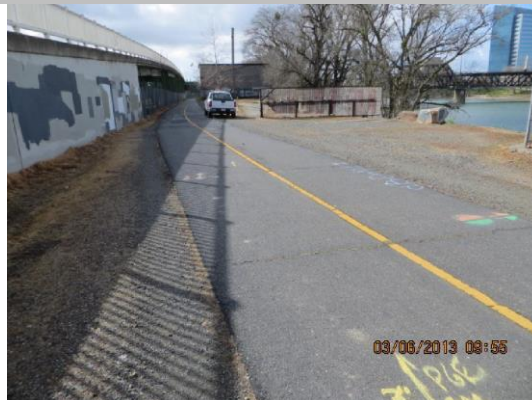
Photo 1 of 2 : UCIP\_FA\_2016\_49956\_72627.jpg

LM Start	0.15	Rating **	U	Issue No.	886
LM End	0.15	Issue Type +	En	Location *	N/A
Category	Supplemental			GPS Latitude/Longitude	
				Start	End
Item	DWR UCIP Field Study			38.588636 °	38.588636 °
				-121.504860 °	-121.504860 °
DWR ID					
Comment Code					
Inspector Comment					
FS_ID:49956 DS_ID:24884 EP_NO: N/A Repair Type: Urgent Crossing Status: Indicator Found UCIP Comments: 07/19/2016 same as previous inspection. Need to contact owner to determine status of crossing. Unable to confirm alignment or depth through the levee crown. (DWR UCIP - omagana)10/17/2014 No markers found. Need to contact owner to determine status of crossing and to determine last inspection date. (DWR UCIP - omagana) FIELD_STRUCT_DESC: 3-inch steel gas line though levee at unknown depth. Undergroud alert service (USA) markings indicate this line is a PG&E line visible in 2013. FS Date: 7/19/2016

View of levee crown and alignment of PG&amp;E line visible by yellow paint markings.

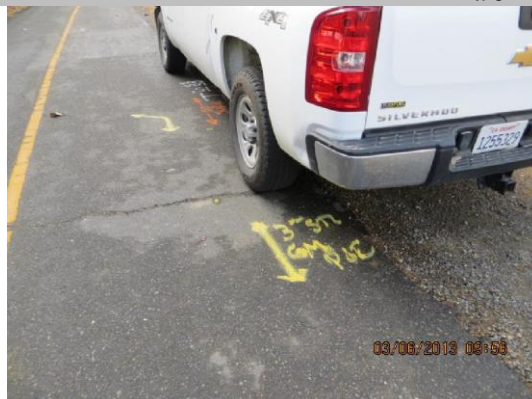
Photo 2 of 2 : UCIP\_FA\_2016\_49956\_72626.jpg

Item	DWR UCIP Field Study			38.588636 °	38.588636 °	
				-121.504860 °	-121.504860 °	
DWR ID						
Comment Code						
Inspector Comment						
FS_ID:49956 DS_ID:24884 EP_NO: N/A Repair Type: Urgent Crossing Status: Indicator Found UCIP Comments: 07/19/2016 same as previous inspection. Need to contact owner to determine status of crossing. Unable to confirm alignment or depth through the levee crown. (DWR UCIP - omagana)10/17/2014 No markers found. Need to contact owner to determine status of crossing and to determine last inspection date. (DWR UCIP - omagana) FIELD_STRUCT_DESC: 3-inch steel gas line though levee at unknown depth. Undergroud alert service (USA) markings indicate this line is a PG&E line visible in 2013. FS Date: 7/19/2016

Underground Service Alert (USA) markings of PG&E line through levee, Photo 1 of 2.

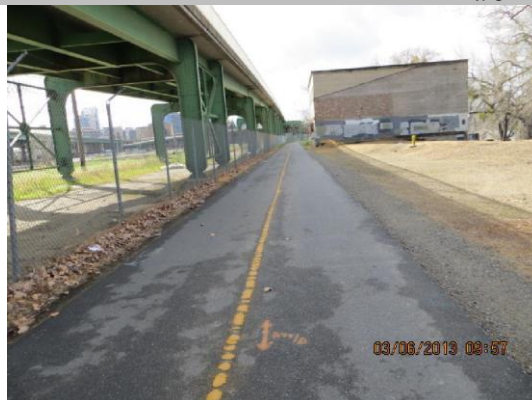
Photo 1 of 2 : UCIP\_FA\_2016\_41416\_72629.jpg

LM Start	0.16	Rating **	M	Issue No.	830
LM End	0.16	Issue Type +	En	Location *	N/A
Category	Supplemental			GPS Latitude/Longitude	
				Start	End
Item	DWR UCIP Field Study			38.588500 °	38.588500 °
				-121.504856 °	-121.504856 °
DWR ID					
Comment Code					
Inspector Comment					
FS_ID:41416					
DS_ID:24885					
EP_NO: N/A					
Repair Type: Non-Urgent					
Crossing Status: Indicator Found					
UCIP Comments: No markers visible as per Title 23. Recommend having utility owner coordinate with Central Valley Flood Protection Board (CVFPB).					
FIELD_STRUCT_DESC: ATT communication line through levee at unknown depth.					
FS Date: 3/6/2013

Alignment of communication line through levee, Photo 1 of 2.

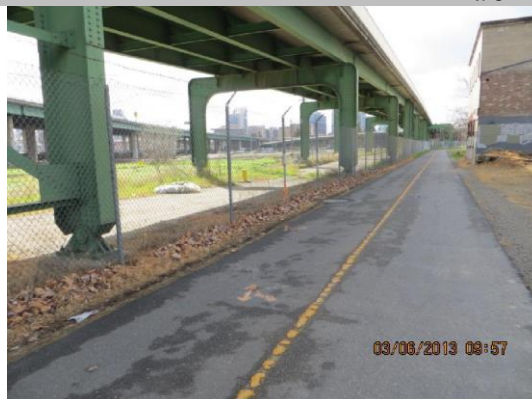
Photo 2 of 2 : UCIP\_FA\_2016\_41416\_72628.jpg

LM Start	0.16	Rating **	M	Issue No.	830 (cont)	
LM End	0.16	Issue Type +	En	Location *	N/A	
Category	Supplemental			GPS Latitude/Longitude		
				Start	End	
Item	DWR UCIP Field Study			38.588500 °	38.588500 °	
				-121.504856 °	-121.504856 °	
DWR ID						
Comment Code						
Inspector Comment						
FS_ID:41416						
DS_ID:24885						
EP_NO: N/A						
Repair Type: Non-Urgent						
Crossing Status: Indicator Found						
UCIP Comments: No markers visible as per Title 23. Recommend having utility owner coordinate with Central Valley Flood Protection Board (CVFPB).						
FIELD_STRUCT_DESC: ATT communication line through levee at unknown depth.						
FS Date: 3/6/2013

Alignment of communication line through levee, Photo 2 of 2.

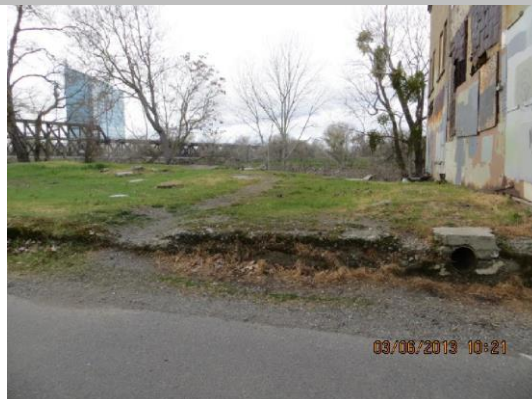
Photo 2 of 2 : UCIP\_FA\_2016\_40848\_72632.jpg

FS\_ID:40848  
DS\_ID:24887  
EP\_NO: N/A  
Repair Type: Non-Urgent  
Crossing Status: Indicator Found  
UCIP Comments: Pump station appears non-functional. Owner will need to coordinate with DWR-Inspector and CVFPB to determine if crossing meets Title 23 requirements.  
FIELD\_STRUCT\_DESC: 12 inch connected to 10 inch pipe through levee at unknown depth.  
FS Date: 3/6/2013

View of levee crown at crossing.

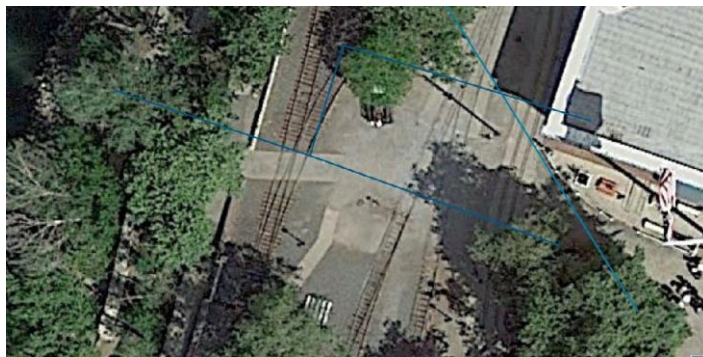
Photo 1 of 1 : UCIP\_FA\_2016\_41247\_72740.jpg

LM Start	0.42	Rating **	M	Issue No.	864
LM End	0.42	Issue Type +	En	Location *	N/A
Category	Supplemental			GPS Latitude/Longitude	
				Start	End
Item	DWR UCIP Field Study			38.584794 °	38.584794 °
				-121.505548 °	-121.505548 °
DWR ID					
Comment Code					
Inspector Comment					
FS_ID:41247					
DS_ID:24889					
EP_NO: N/A					
Repair Type: Non-Urgent					
Crossing Status: Indicator Found					
UCIP Comments: Unable to confirm if crossing exists. Approximate alignment provided by the City of Sacramento. Need to confirm alignment and status of crossing.					
FIELD_STRUCT_DESC: 10 inch pipe through levee. Record was obtained from Sacramento County approximate utility alignment.					
FS Date: 3/6/2013

Alignment provided by City of Sacramento of 10 inch line--not found during field inspection.

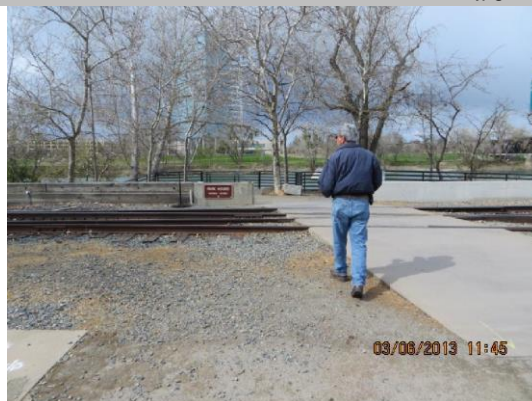
Photo 1 of 2 : UCIP\_FA\_2016\_20384\_34410.jpg

LM Start	0.42	Rating **	M	Issue No.	826
LM End	0.42	Issue Type +	En	Location *	N/A
Category	Supplemental			GPS Latitude/Longitude	
				Start	End
Item	DWR UCIP Field Study			38.584762 °	38.584762 °
				-121.505556 °	-121.505556 °
DWR ID					
Comment Code					
Inspector Comment					
FS_ID:20384					
DS_ID:21561					
EP_NO: N/A					
Repair Type: Non-Urgent					
Crossing Status: Indicator Found					
UCIP Comments: Only manhole was visible; need to determine condition of crossing; Will need to follow up with the City of Sacramento.					
FIELD_STRUCT_DESC: 18-inch-diameter storm drain through the levee, 5 feet below the crown. Concrete surge box on the waterward side of the retaining wall. Concrete box spillway.					
FS Date: 3/6/2013

View of levee crown downtown Sacramento--wide crown with railroad.

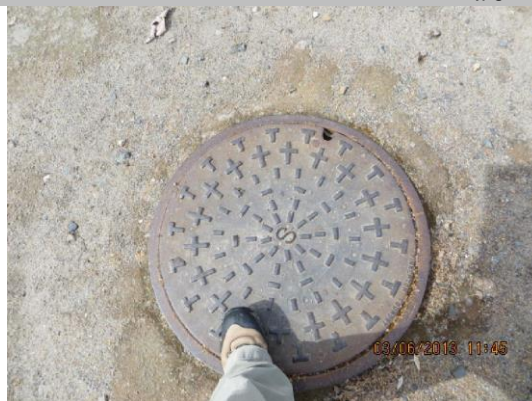
Photo 2 of 2 : UCIP\_FA\_2016\_20384\_34409.jpg

LM Start	0.42	Rating **	M	Issue No.	826 (cont)	
LM End	0.42	Issue Type +	En	Location *	N/A	
Category	Supplemental			GPS Latitude/Longitude		
				Start	End	
Item	DWR UCIP Field Study			38.584762 °	38.584762 °	
				-121.505556 °	-121.505556 °	
DWR ID						
Comment Code						
Inspector Comment						
FS_ID:20384						
DS_ID:21561						
EP_NO: N/A						
Repair Type: Non-Urgent						
Crossing Status: Indicator Found						
UCIP Comments: Only manhole was visible; need to determine condition of crossing; Will need to follow up with the City of Sacramento.						
FIELD_STRUCT_DESC: 18-inch-diameter storm drain through the levee, 5 feet below the crown. Concrete surge box on the waterward side of the retaining wall. Concrete box spillway.						
FS Date: 3/6/2013

View of manhole located at the edge of waterward.

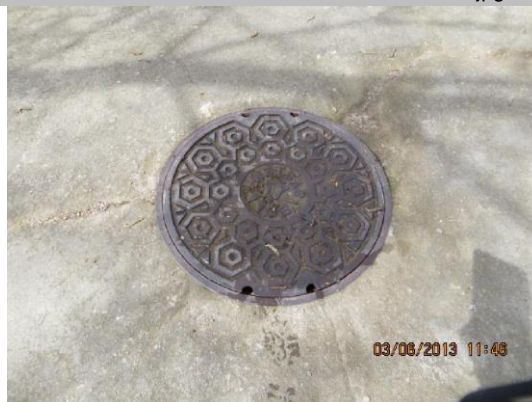
Photo 1 of 2 : UCIP\_FA\_2016\_41417\_72642.jpg

LM Start	0.42	Rating **	M	Issue No.	831
LM End	0.42	Issue Type +	En	Location *	N/A
Category	Supplemental			GPS Latitude/Longitude	
				Start	End
Item	DWR UCIP Field Study			38.584767 °	38.584767 °
				-121.505700 °	-121.505700 °
DWR ID					
Comment Code					
Inspector Comment					
FS_ID:41417 DS_ID:24890 EP_NO: N/A Repair Type: Non-Urgent Crossing Status: Indicator Found UCIP Comments: Need additional information about crossing--depth of pipe, owner, status, and permit. FIELD_STRUCT_DESC: Submarine cable from the bed of the Sacramento River through and along the natural west levee of the river at a depth of 2 feet to a point in the town of Broderick, opposite a point approximately 434 feet downstream from the "I" Street Bridge, Sacramento. (Permit No. 881, 1942) FS Date: 3/6/2013

PacBell manhole located on waterward side.

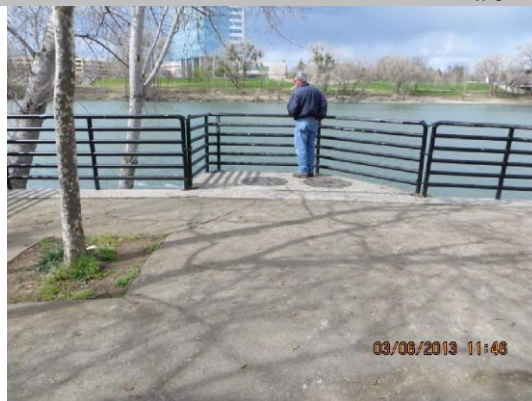
Photo 2 of 2 : UCIP\_FA\_2016\_41417\_72641.jpg

LM Start	0.42	Rating **	M	Issue No.	831 (cont)	
LM End	0.42	Issue Type +	En	Location *	N/A	
Category	Supplemental			GPS Latitude/Longitude		
				Start		End
Item	DWR UCIP Field Study			38.584767 °		38.584767 °
				-121.505700 °		-121.505700 °
DWR ID						
Comment Code						
Inspector Comment						
FS_ID:41417						
DS_ID:24890						
EP_NO: N/A						
Repair Type: Non-Urgent						
Crossing Status: Indicator Found						
UCIP Comments: Need additional information about crossing--depth of pipe, owner, status, and permit.						
FIELD_STRUCT_DESC: Submarine cable from the bed of the Sacramento River through and along the natural west levee of the river at a depth of 2 feet to a point in the town of Broderick, opposite a point approximately 434 feet downstream from the "I" Street Bridge, Sacramento. (Permit No. 881, 1942)						
FS Date: 3/6/2013

Manholes located along levee--waterward side.

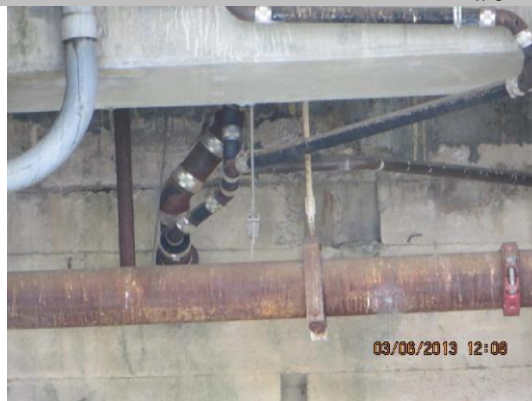
Photo 1 of 1 : UCIP\_FA\_2016\_41260\_72743.jpg

LM Start	0.57	Rating **	M	Issue No.	865
LM End	0.57	Issue Type +	En	Location *	N/A
Category	Supplemental			GPS Latitude/Longitude	
				Start	End
Item	DWR UCIP Field Study			38.582689 °	38.582689 °
				-121.506419 °	-121.506419 °
DWR ID					
Comment Code					
Inspector Comment					
FS_ID:41260 DS_ID:24896 EP_NO: N/A Repair Type: Non-Urgent Crossing Status: Indicator Found UCIP Comments: Unable to determine if crossing is active--need to contact owner to determine status and additional details of crossing. FIELD_STRUCT_DESC: Conduit group through floodwall. FS Date: 3/6/2013

Conduit through floodwall.

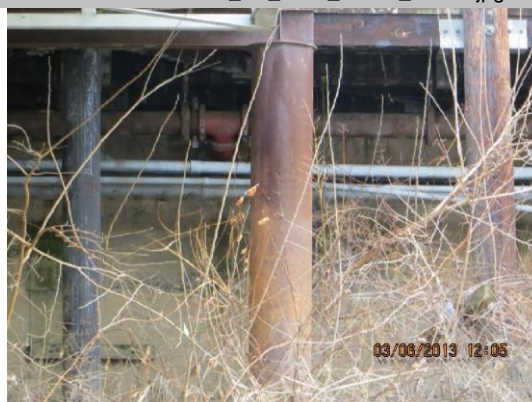
Photo 1 of 1 : UCIP\_FA\_2016\_41263\_72744.jpg

LM Start	0.59	Rating **	M	Issue No.	866
LM End	0.59	Issue Type +	En	Location *	N/A
Category	Supplemental			GPS Latitude/Longitude	
				Start	End
Item	DWR UCIP Field Study			38.582482 °	38.582482 °
				-121.506346 °	-121.506346 °
DWR ID					
Comment Code					
Inspector Comment					
FS_ID:41263					
DS_ID:24897					
EP_NO: N/A					
Repair Type: Non-Urgent					
Crossing Status: Indicator Found					
UCIP Comments: Need to contact owner. Need to determine permit issued for crossing.					
FIELD_STRUCT_DESC: 8 -10 inch pipe through levee.					
FS Date: 3/6/2013

Pipe through floodwall.

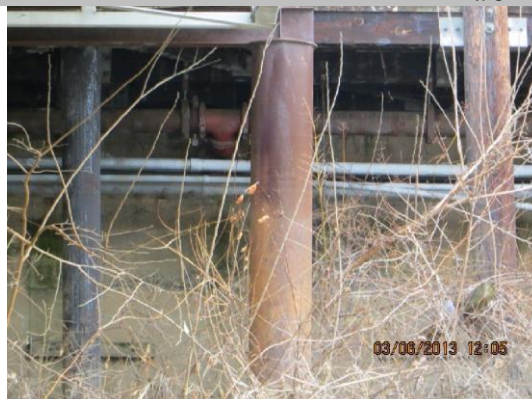
Photo 1 of 1 : UCIP\_FA\_2016\_41438\_72745.jpg

LM Start	0.61	Rating **	M	Issue No.	870
LM End	0.61	Issue Type +	En	Location *	N/A
Category	Supplemental			GPS Latitude/Longitude	
				Start	End
Item	DWR UCIP Field Study			38.582167 °	38.582167 °
				-121.506537 °	-121.506537 °
DWR ID					
Comment Code					
Inspector Comment					
FS_ID:41438 DS_ID:24898 EP_NO: N/A Repair Type: Non-Urgent Crossing Status: Indicator Found UCIP Comments: Unable to determine if crossing is active--need to contact owner to determine status and additional details of crossing. FIELD_STRUCT_DESC: Sewer line through levee. FS Date: 3/6/2013

View of crossing visible from waterward side looking at floodwall.

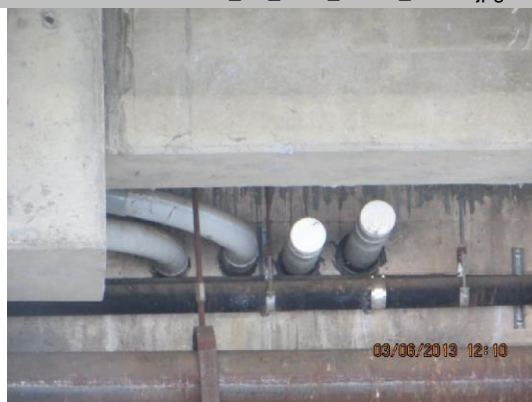
Photo 1 of 1 : UCIP\_FA\_2016\_41420\_72746.jpg

LM Start	0.64	Rating **	M	Issue No.	834
LM End	0.64	Issue Type +	En	Location *	N/A
Category	Supplemental			GPS Latitude/Longitude	
				Start	End
Item	DWR UCIP Field Study			38.581695 °	38.581695 °
				-121.506635 °	-121.506635 °
DWR ID					
Comment Code					
Inspector Comment					
FS_ID:41420 DS_ID:24899 EP_NO: N/A Repair Type: Non-Urgent Crossing Status: Indicator Found UCIP Comments: Need to contact owner to determine permit issued for crossing. FIELD_STRUCT_DESC: Group of conduits. Start 38.58169451, -121.5066352 End 38.581555, -121.506688 FS Date: 3/6/2013

View of conduits through floodwall visible from waterward side.

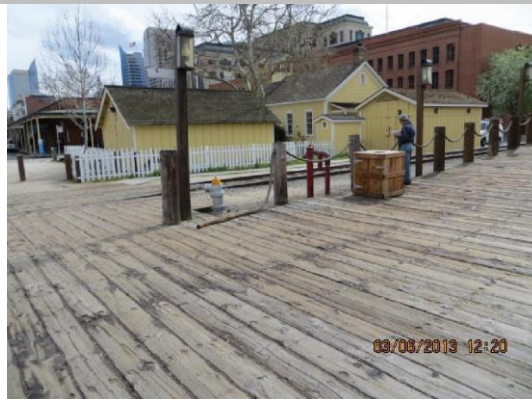
Photo 1 of 1 : UCIP\_FA\_2016\_41266\_72747.jpg

Fire hydrant visible on levee crown.

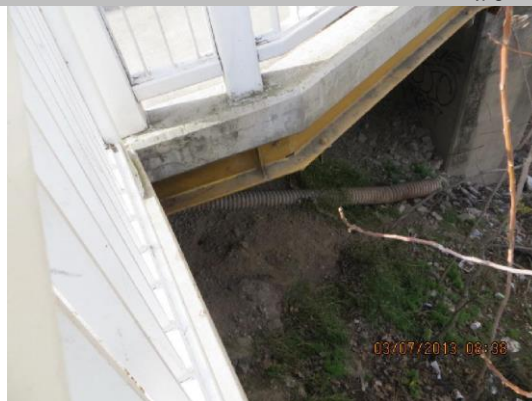
Photo 2 of 2 : UCIP\_FA\_2016\_41421\_72749.jpg

Pipe visible on waterward side.

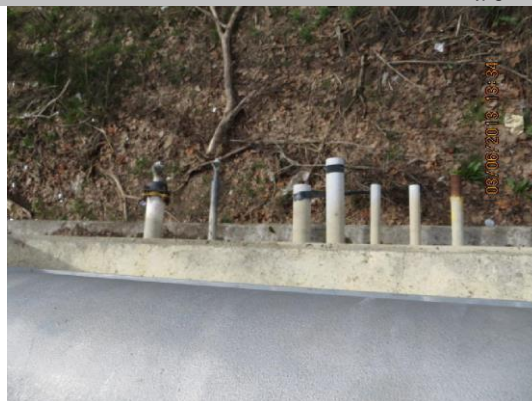
Photo 2 of 2 : UCIP\_FA\_2016\_41422\_72753.jpg

Conduits through floodwayll.

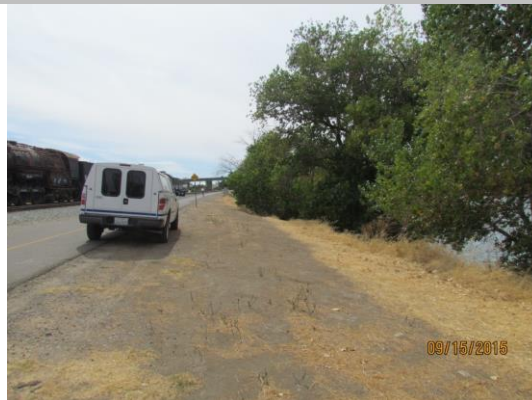
Photo 1 of 2 : FA\_2016\_NA0005\_251\_13\_20160913\_00010.jpg

Monitor trees and woody vegetation along the rivers edge looking downstream. Fall 2015.

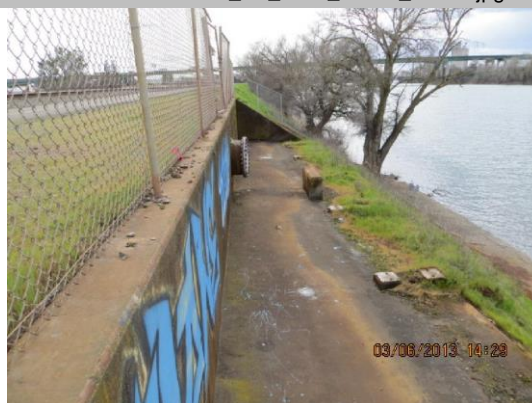
Photo 2 of 2 : UCIP\_FA\_2016\_41425\_34144.jpg

Headwall with 1 crossing capped off.

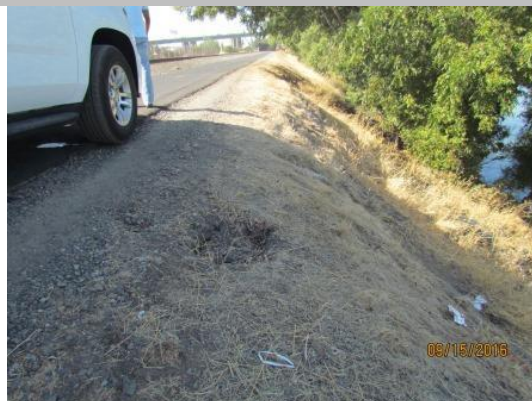
Photo 1 of 1 : FA\_2016\_NA0005\_251\_76\_20160915\_00116.jpg

Rodent hole backfilled with natural soil on waterward side of the levee. Fall 2016 inspection.

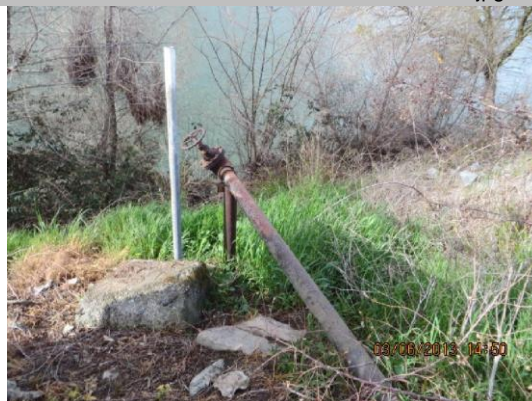
Photo 2 of 2 : UCIP\_FA\_2016\_49767\_34066.jpg

View of pipe and gate valve located on waterward slope.

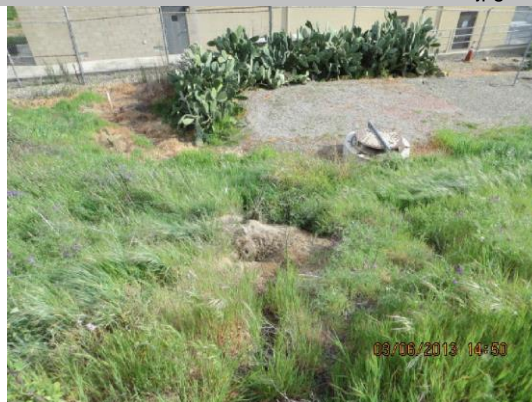
Photo 2 of 2 : UCIP\_FA\_2016\_49957\_34072.jpg

View of landward side--tall grass along slope limit inspection.

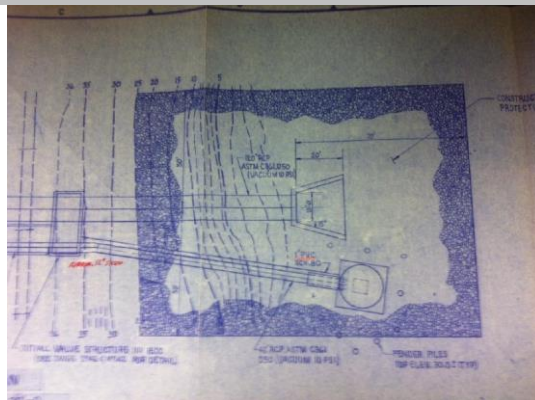
Photo 2 of 2 : UCIP\_FA\_2016\_49778\_34027.jpg

Rip rap protection around outfall structure for 42-inch and 120-inch pipes.

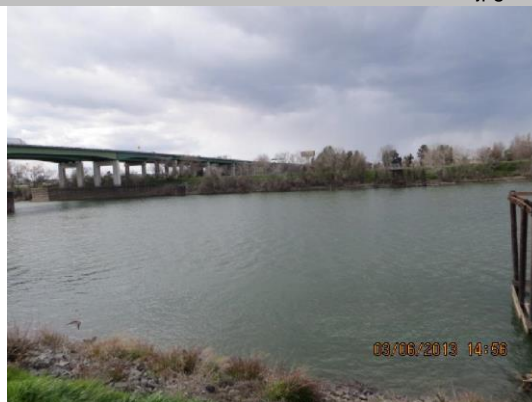
Photo 2 of 2 : UCIP\_FA\_2016\_49958\_34050.jpg

View of waterward side--outlet submerged.

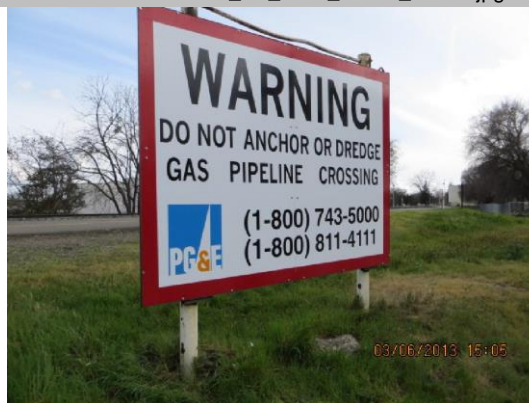
Photo 1 of 2 : UCIP\_FA\_2016\_32883\_59502.jpg

PG&amp;E warning gas line crossing--waterward side view.

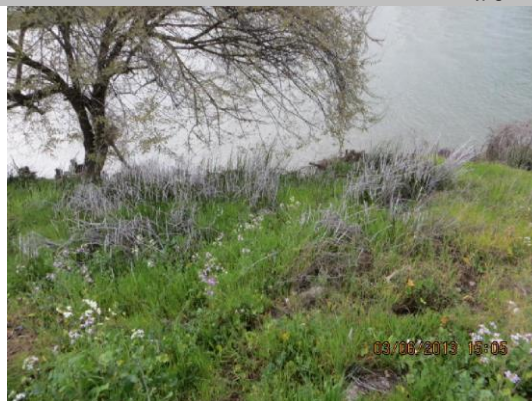
Photo 2 of 2 : UCIP\_FA\_2016\_32883\_59501.jpg

View of waterward slope--tall grass limits inspection.

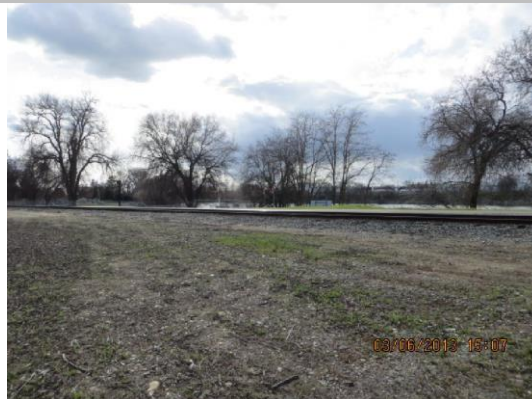
Photo 2 of 2 : UCIP\_FA\_2016\_41442\_59559.jpg

View of crossing approximately 110 feet downstream--large sign located on waterward slope.

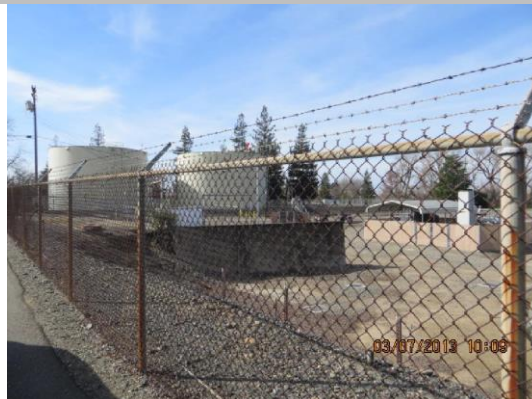
Photo 1 of 1 : UCIP\_FA\_2016\_41444\_59572.jpg

Concrete structure still remain in lot on waterward side.

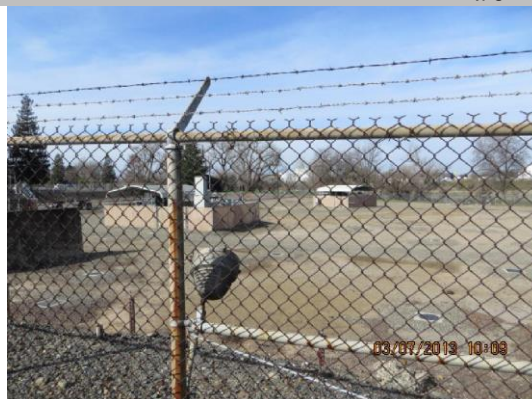
Photo 1 of 2 : UCIP\_FA\_2016\_41282\_59575.jpg

Structures present inside lot--site of Ozone Injection and Soil Vapor Extration System for the former Tosco Bulk Fuel.

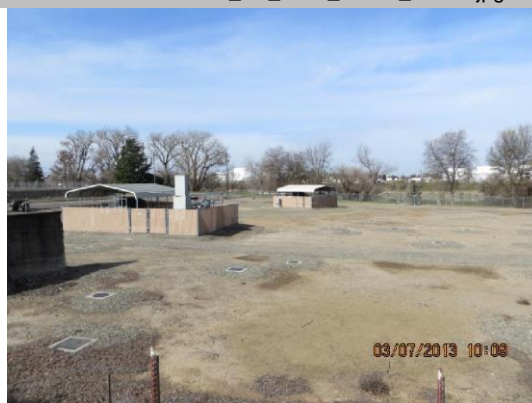
Photo 2 of 2 : UCIP\_FA\_2016\_41282\_59574.jpg

Several vapor wells present inside fenced area.

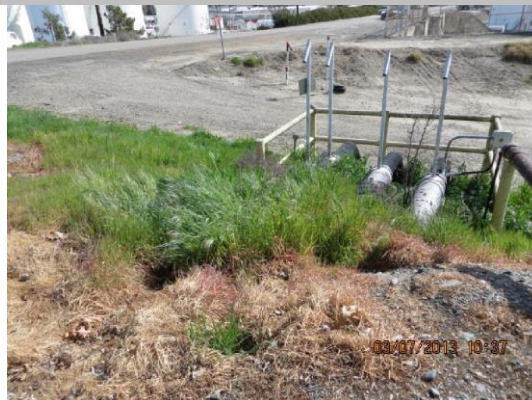
Photo 2 of 2 : UCIP\_FA\_2016\_41452\_59524.jpg

Dense burrow activity along landward slope.

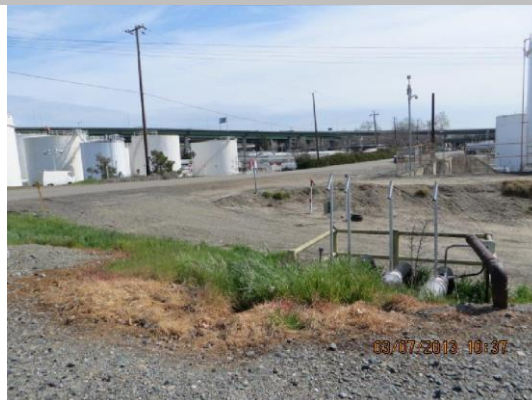
Photo 2 of 2 : UCIP\_FA\_2016\_41448\_59510.jpg

Overview of 4-10 inch lines through levee--landward side.

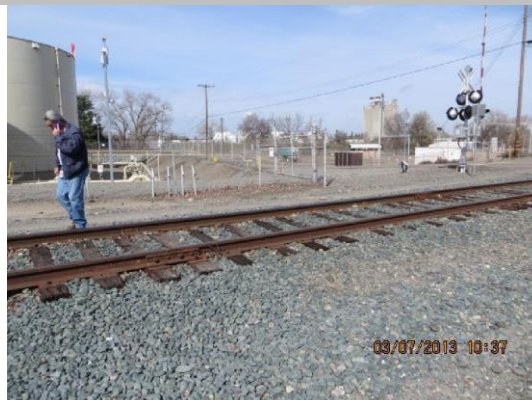
Photo 2 of 2 : UCIP\_FA\_2016\_41449\_59517.jpg

View of waterward side--markers visible along chain link fence.

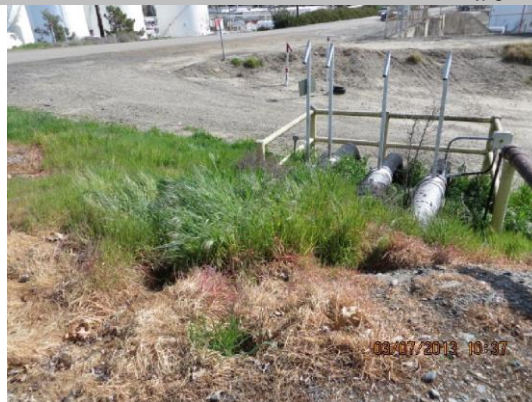
Photo 2 of 2 : UCIP\_FA\_2016\_48322\_59520.jpg

Dense burrow activity along levee slope.

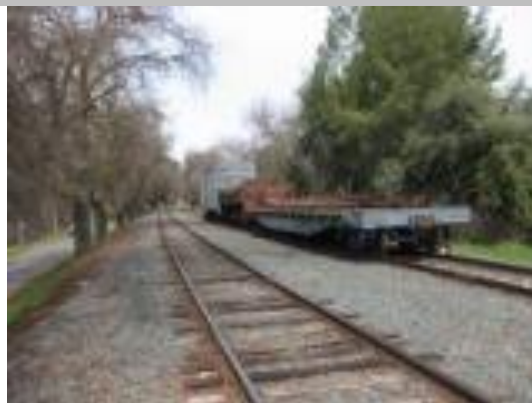
Photo 1 of 4 : FA\_2016\_NA0005\_251\_7\_20160913\_00004.jpg

The railroad cars remain on the levee crown. Spring 2013

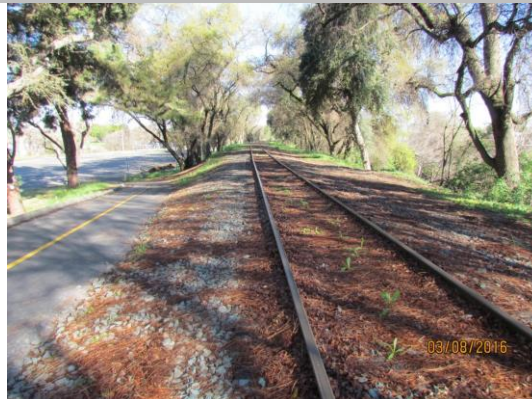
Photo 4 of 4 : FA\_2016\_NA0005\_251\_7\_20160913\_00007.jpg

View of the railroad tracks at levee mile 2.34 on the crown of the levee looking upstream. Spring 2016.

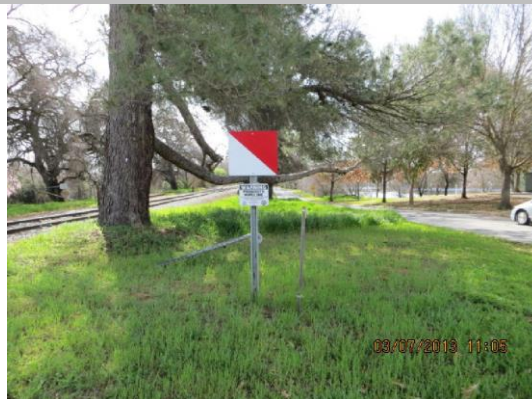
Photo 1 of 1 : UCIP\_FA\_2016\_41291\_72758.jpg

Marker of gas line visible on levee crown next to railroad tracks.

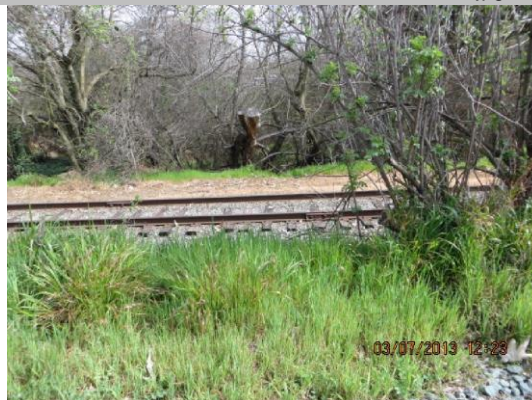
Photo 2 of 2 : UCIP\_FA\_2016\_41295\_72763.jpg

Dense vegetation along landward slope.

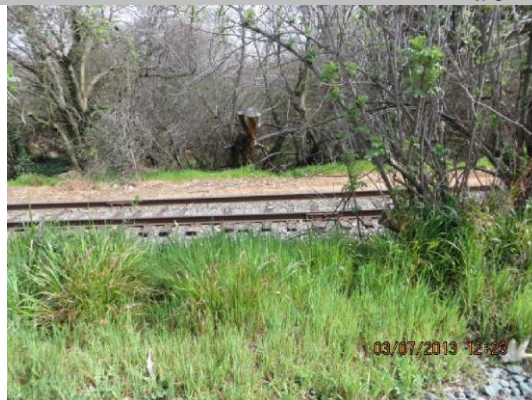
Photo 2 of 2 : UCIP\_FA\_2016\_38827\_72765.jpg

Dense vegetation on landward side.

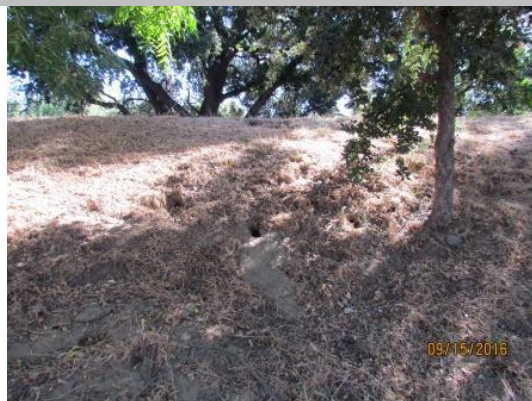
Photo 1 of 1 : FA\_2016\_NA0005\_251\_77\_20160915\_00118.jpg

More squirrel holes found on waterward slope. Fall 2016.

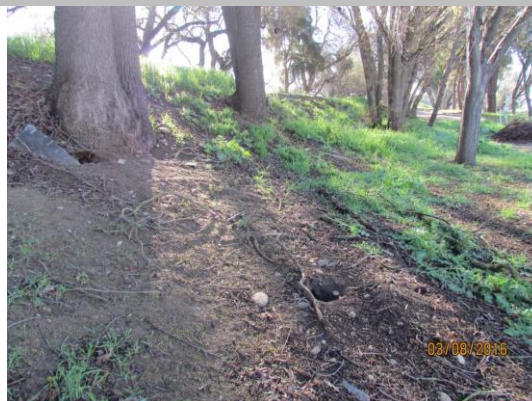
Photo 1 of 1 : FA\_2016\_NA0005\_251\_82\_20160913\_00014.jpg

View of the rodent holes on the waterward side of the levee looking downstream. Spring 2016.

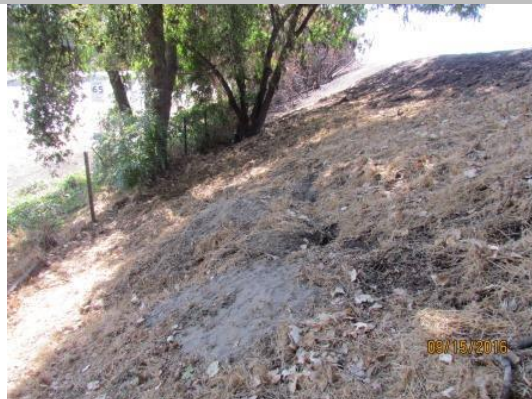
Photo 1 of 1 : FA\_2016\_NA0005\_251\_78\_20160915\_00119.jpg

Rodent holes with more than 2 cub ft. of soil taken out found on landside slope of the levee. Fall 2016.

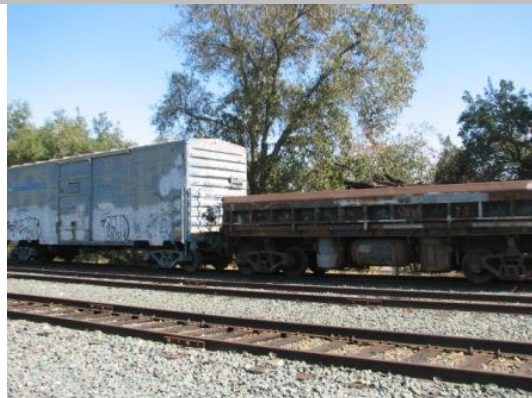
Photo 1 of 1 : FA\_2016\_NA0005\_251\_9\_20160913\_00008.jpg

Trains cars are stored on the crown of the levee. Fall 2013

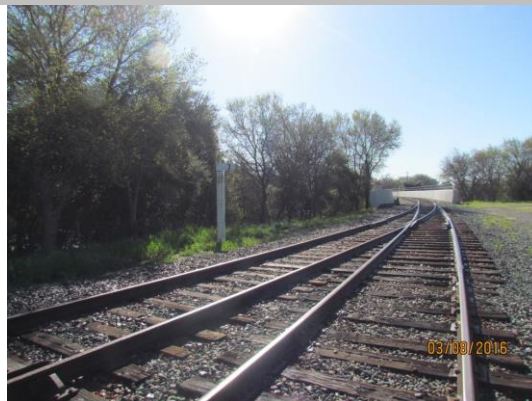
Photo 2 of 2 : FA\_2016\_NA0005\_251\_85\_20160913\_00016.jpg

Perspective view of the trees on the landward side of the levee looking downstream. Spring 2016.
